Horizon 2020
European Union Funding
for Research & Innovation

D4.4 – Outcomes of testing activities

Project Acronym	EENSULATE
Project Title	Development of innovative lightweight and highly insulating energy efficient components and associated enabling materials for cost-effective retrofitting and new construction of curtain wall facades
Grant Agreement n°	723868
Funding Scheme	Innovation Action
Call	H2020- EEB-2016
Topic	EEB-01-2016 Highly efficient insulation materials with improved properties
Starting Date	1 st August 2016
Duration	58 Months

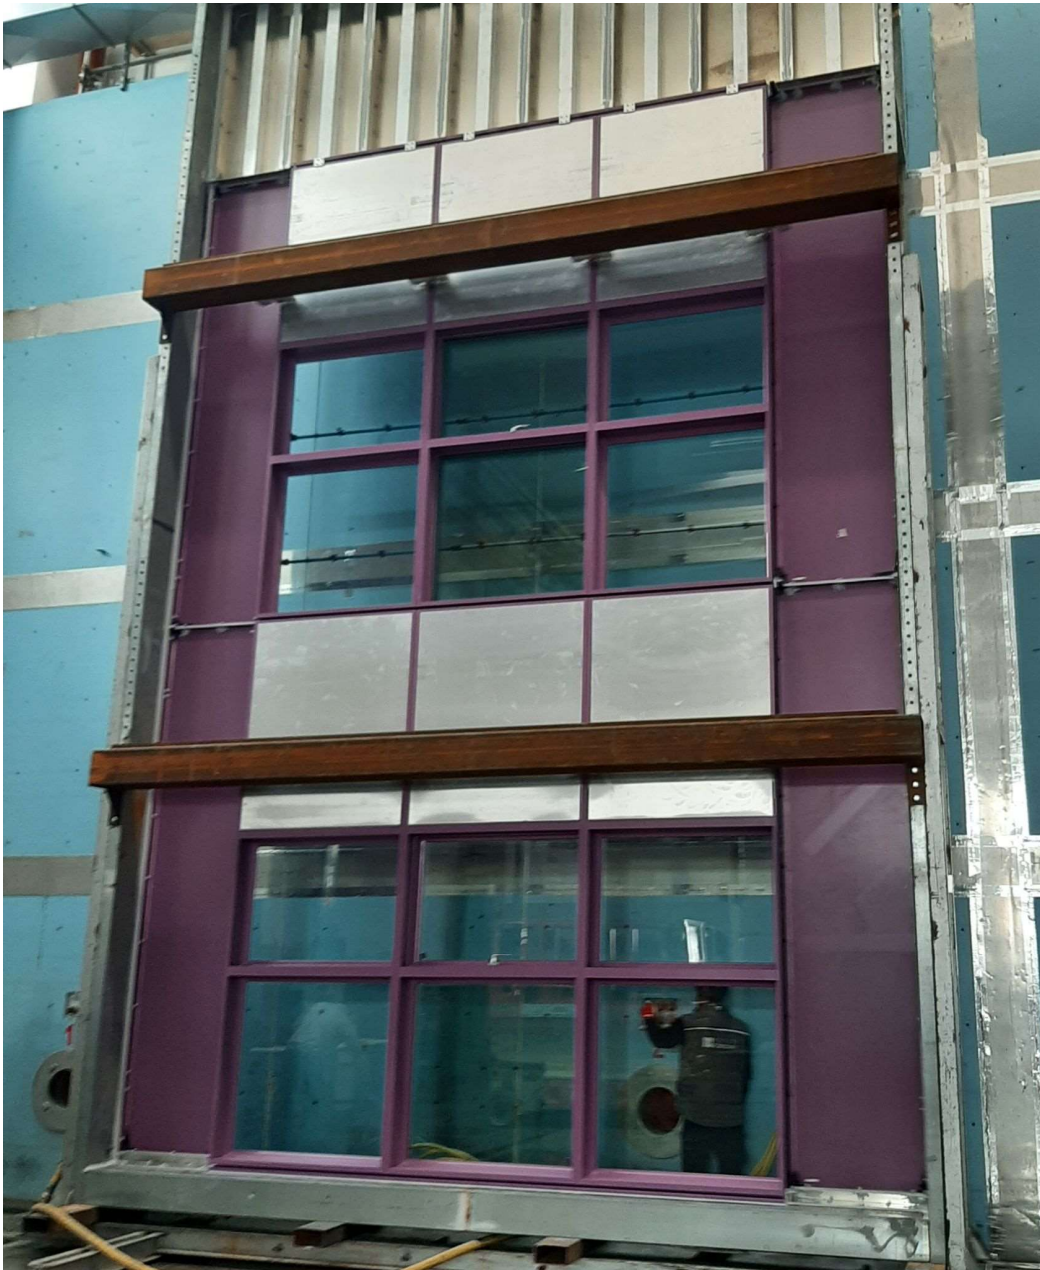
Figure 6 - PMU prototype installed and ready for the test

In line with the test as designed, the PMU has been done in an accredited test chamber and the activities conducted by an independent third party. Figure 6 shows the PMU installed and ready for the test. The other following figures show the PMU during different test sequences.

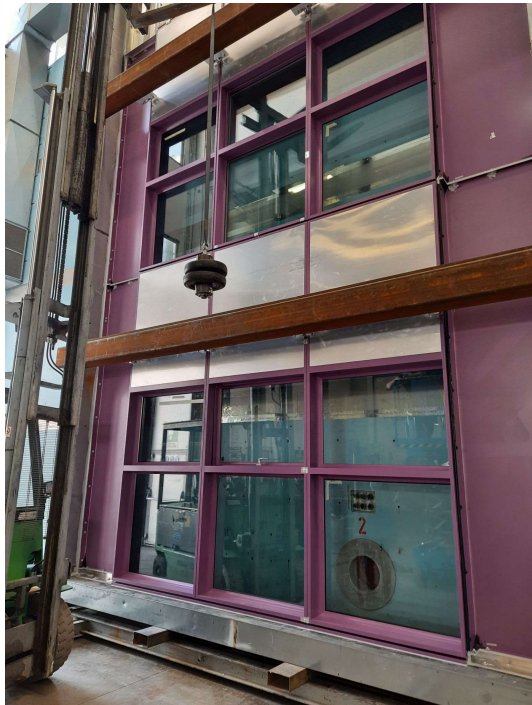
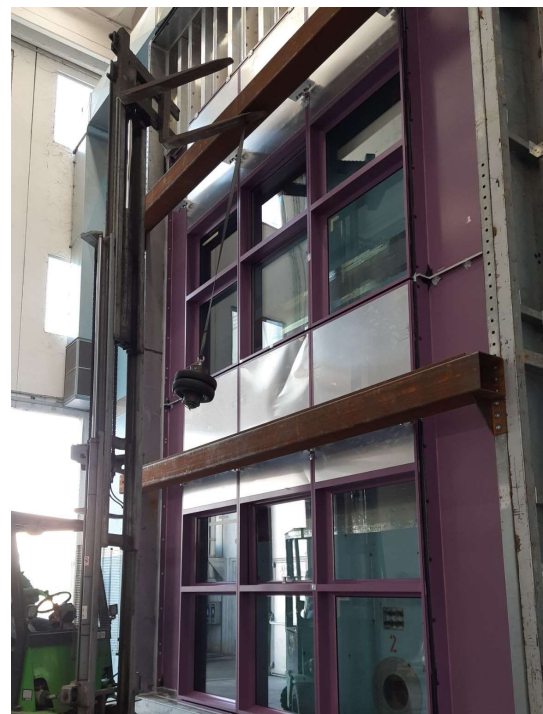
Figure 9 – Impact on the spandrel part top level in the metal sheet

Figure 10 – Impact on the spandrel part top level in the metal sheet

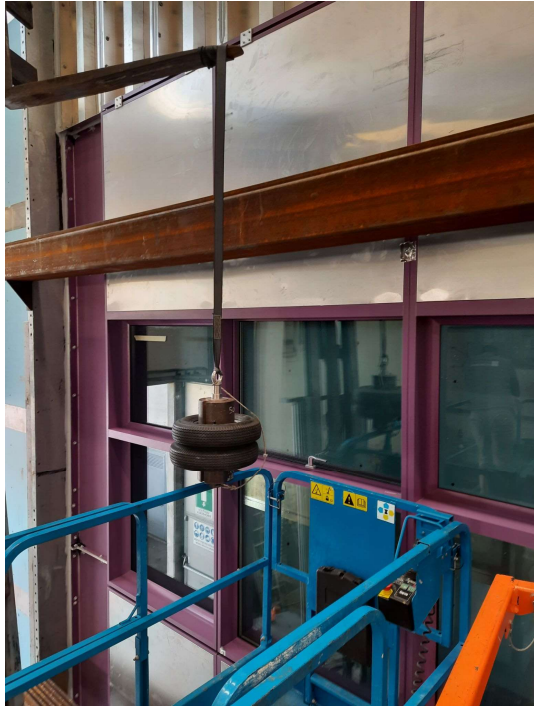
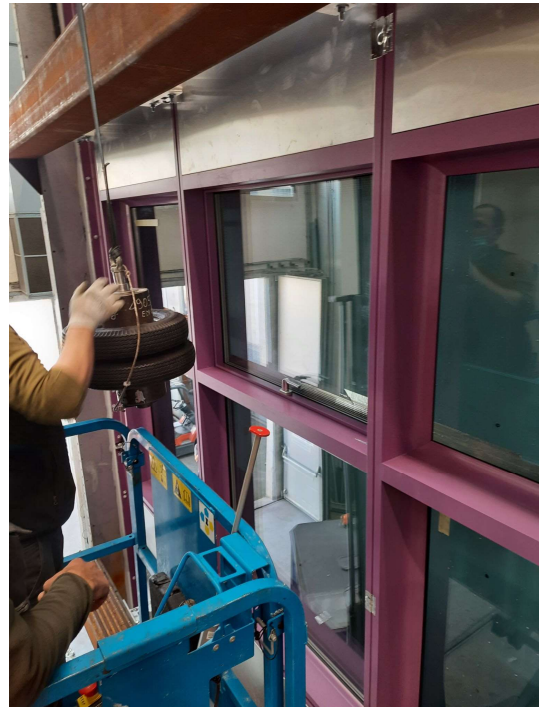
Figure 11 - Impact on the openable vent

Figure 12 - Impact on the openable vent

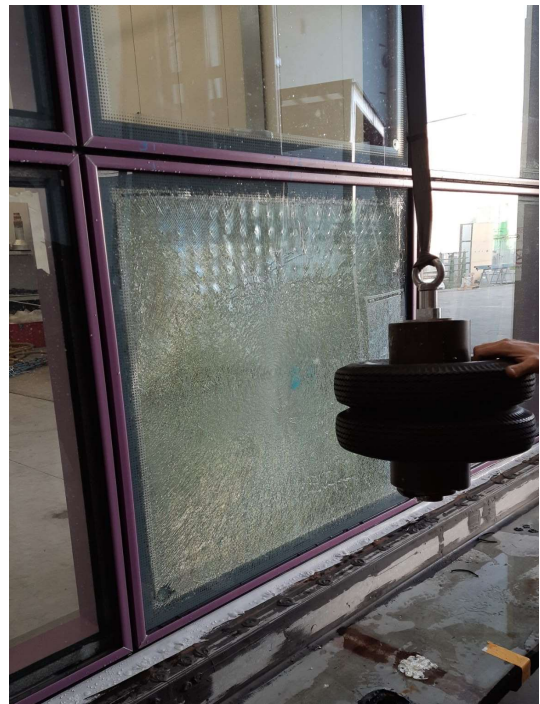
Figure 13 - Impact on the vision unit with VIG

Figure 14 - Impact on the vision unit with VIG

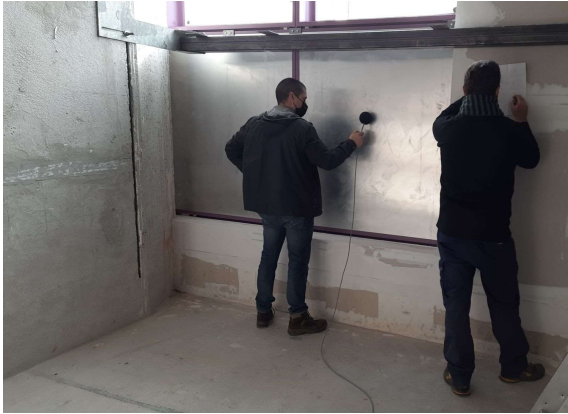
Figure 22 - Acoustic test - during the testing activities

Figure 23 - Acoustic test the sound source positioning

The acoustic test was conducted by placing a sound source on the ground at the distance, from the centre of the item, of at least 7 m with an incidence angle of $45^\circ \pm 5^\circ$. Turning on the sound source, emitting white noise, the sound pressure levels were measured, at the same time, on the external surface of the item and in the receiving room in n° 10 fixed microphone positions randomly distributed; the averaging time was 30 s. Turned off the sound source, in the receiving room the background noise was measured after the reverberation time, using the interrupted noise method.

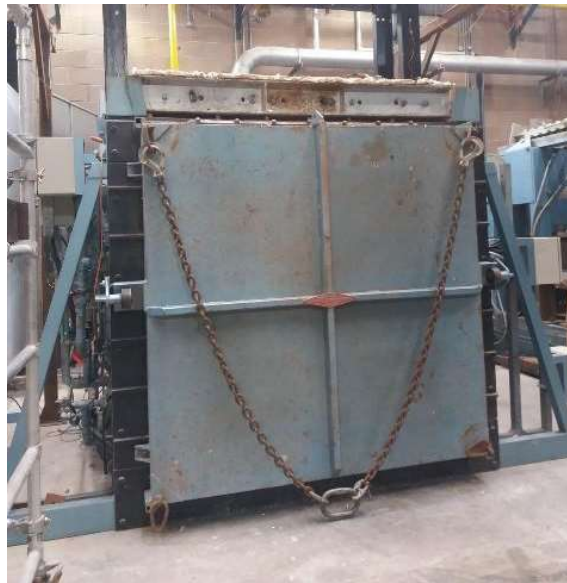
Figure 25 – Medium furnace

A medium sized furnace with an internal compartment measuring 1.5 x 1.5 x 1.5 m³ was utilised for all the tests. The furnace has a top cover and three vertical side walls lined with insulating firebricks to ensure effective heat containment, preventing heat losses which could compromise the accuracy of the test results. Heating was achieved by means of five gas burners located within the walls of the furnace (Figure 26). Each specimen was sandwiched between two vertical plasterboard walls built into the front frame of the furnace as shown in Figure 27.

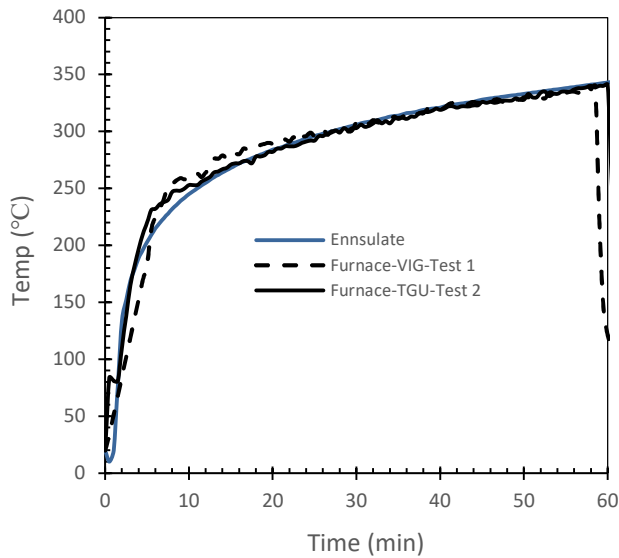
Figure 33 - Batch 1 design fire vs furnace fire

Figure 34 - Batch 2 design fire vs furnace fire

The fire performance of the specimens observed in the tests is discussed in this section. The temperature versus time plots from the installed thermocouples (TC) are presented to provide an insight into the temperature distribution and heat transfer for each specimen during the test. The furnace was programmed to closely follow the design fire curves, i.e. 35% & 50% of the ISO 834 curve. The furnace and design fire temperature versus time plots for both batches presented in Figure 33 and Figure 34 show very reasonable agreement.

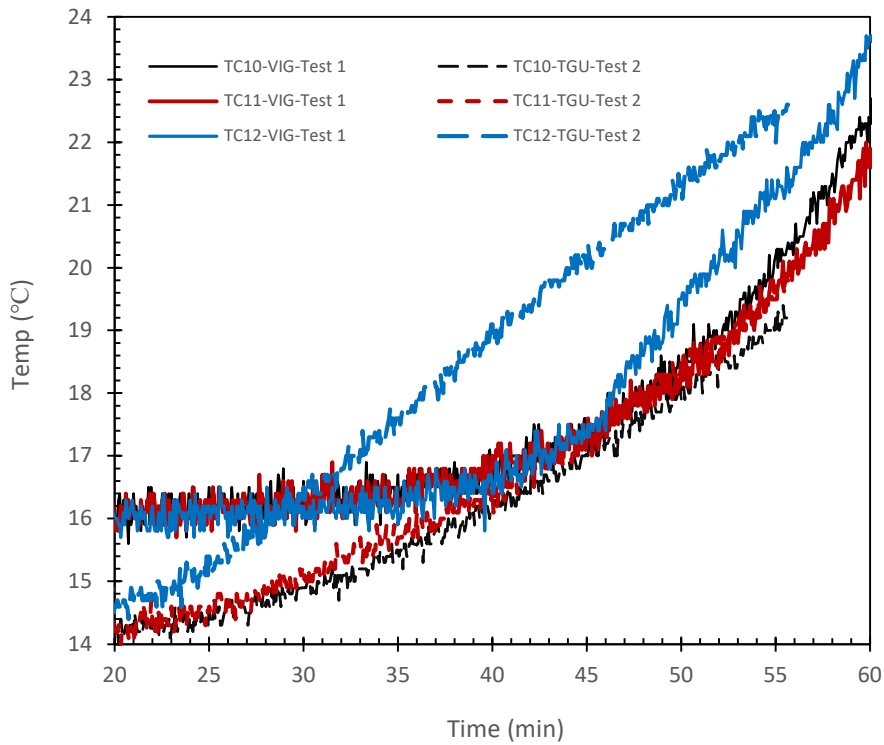
In Figure 36, the readings from TCs 10 to TC 13 are presented. These thermocouples were installed on the spandrel. The plots show that there is no noticeable difference in the readings for the VIG and TGU modules. The curves stayed relatively flat within ambient temperature for the duration of the tests.

Figure 36 - Batch 1 thermocouple data (unexposed spandrel)

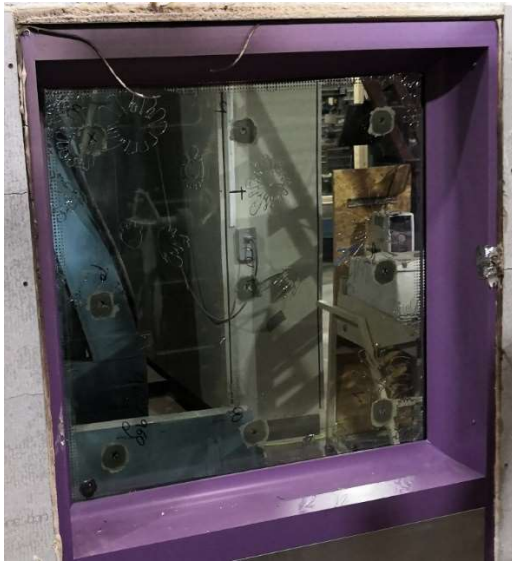
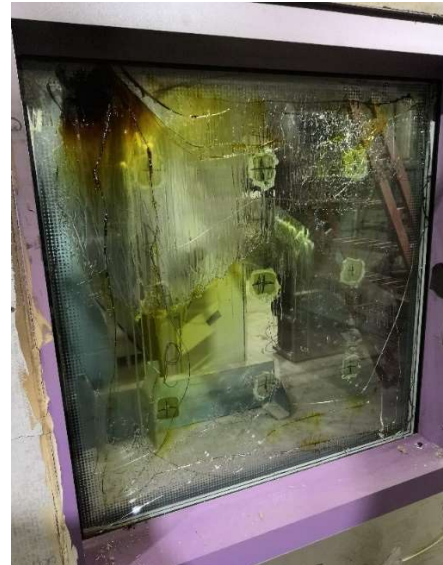
Selected pictures of the post-heating condition of tests 1 and 2 are presented in Figure 37 and Figure 38. Major observation is that cracks occurred in the TGU model at about twenty-seven minutes into the heating,

Figure 37 - Post test condition VIG-T1

Figure 38 - Post test condition TGU-T2

The presence of the cracks seems to have had a negligible effect on the temperatures of the unexposed side of the panel as no unusual rise in the temperature readings was observed.

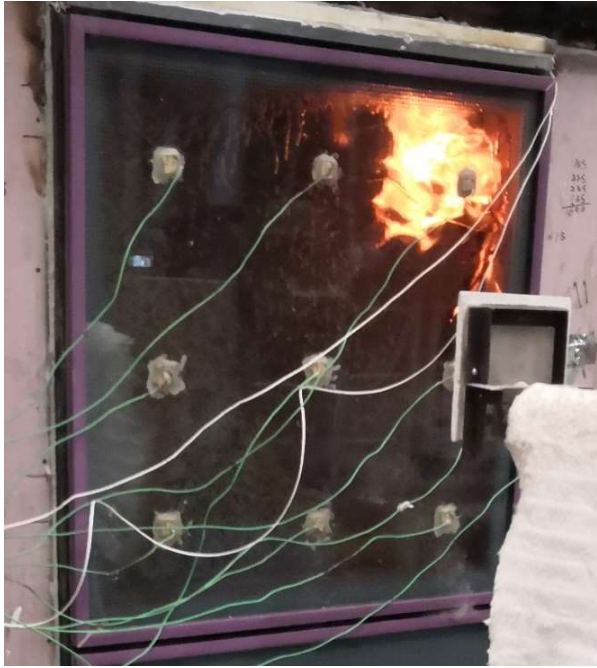
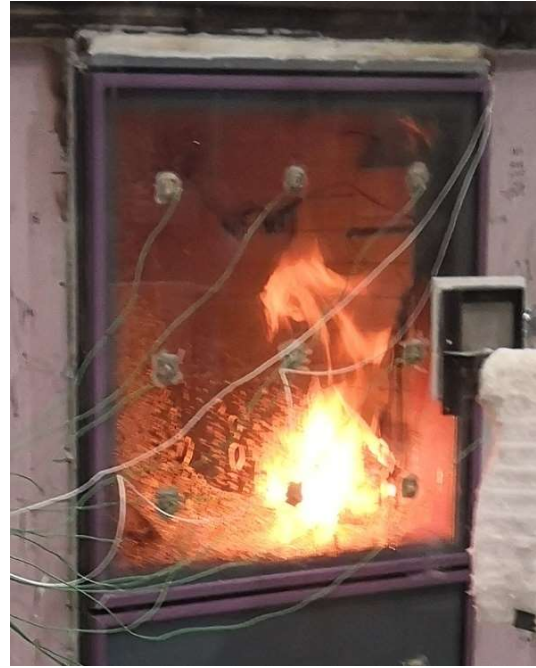
At about 28 minutes post heating, flames appeared at the upper right corner of the TGU panel and lasted for about twenty minutes afterwards as shown in Figure 42 and Figure 43. Pictures of the specimens upon dismantling from the furnace are provided in Figure 44 and Figure 45. It can be observed that whilst the VIG module witnessed some pronounced staining no visible cracks occurred unlike the TGU modules where significant cracks and localised fracture of the glass material occurred. A close-up view of a fractured section of the panel is shown in Figure 46.

Figure 42 - Flame initiation TGU-T4

Figure 43 - Flame propagation TGU-T4

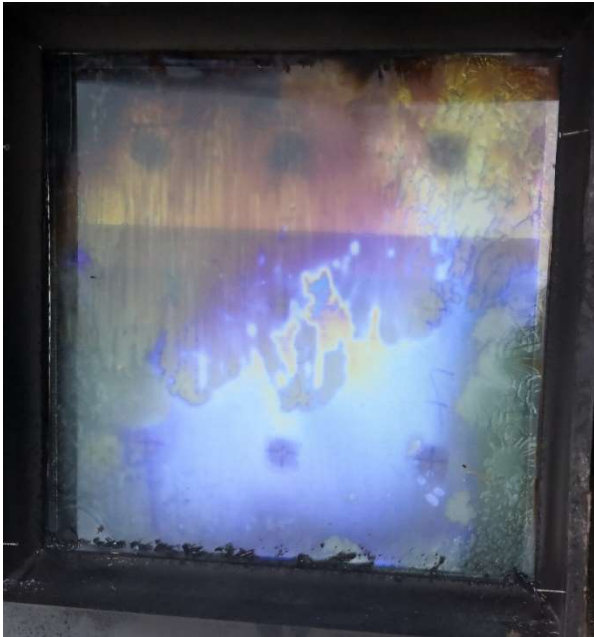
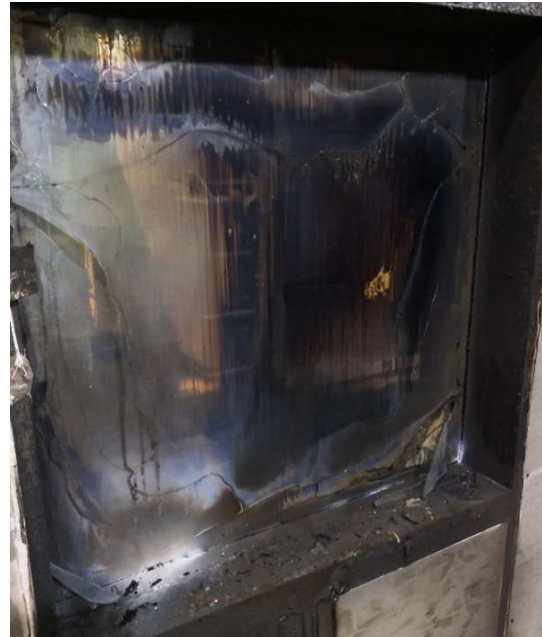
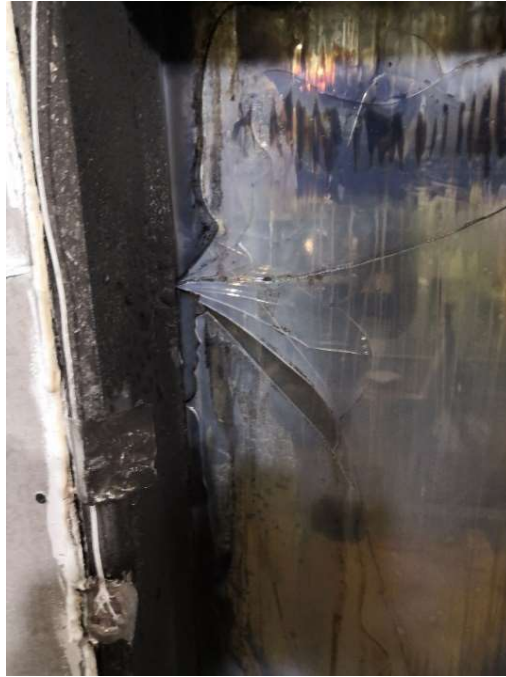
Figure 44 - Post test condition VIG-T3

Figure 45 - Post test condition TGU-T4

Figure 46 - TGU-T4 fractured glass

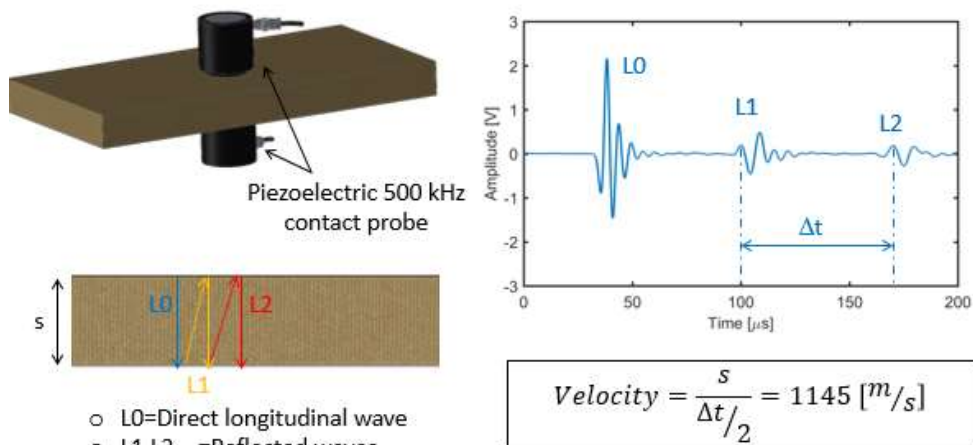
The XPS-insulated panel was characterized by means of precise ultrasonic velocity measurements (see Figure 48) to calculate the speed of the ultrasonic wave which is 1145 m/s.

Figure 48 - Ultrasound speed measurements in XPS – insulated panel.

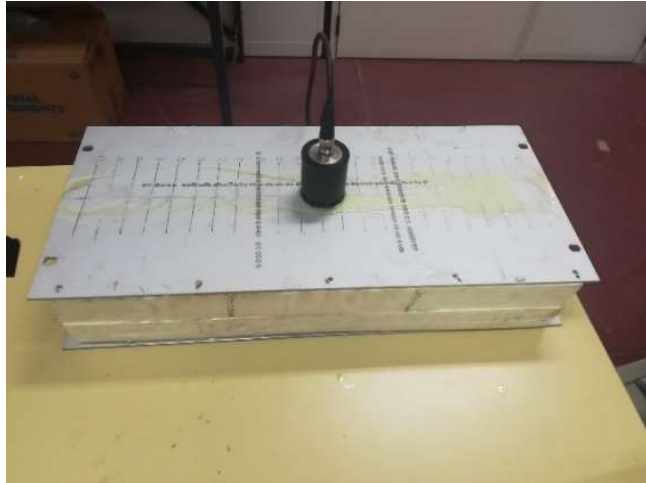
In this case a single probe at 500 kHz was moved with the linear scanning system with a spatial resolution of 10 mm (see Figure 51).

Figure 51 - The UT experimental set-up – Pulse echo mode.

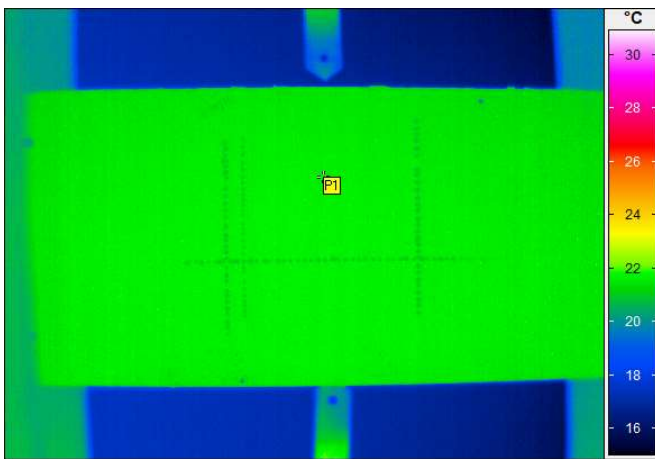
The tests were carried out by setting a frame rate of 1Hz and acquiring 400 images for a total time of 6,66 minutes. An example of thermogram (thermal map showing the emissivity distribution of the sample surface) is given in Figure 55 and Figure 56. Defects are not detectable. One of the main causes of the inefficiency of the thermographic technique is the high reflectivity of the aluminum panel which hinder the heat propagation in the material underneath.

Figure 55 - Thermal mapping provided by IR thermography
