D5.1 – Retrofit process application at the individual testing sites

Project Acronym	EENSULATE
Project Title	Development of innovative lightweight and highly insulating energy efficient components and associated enabling materials for cost-effective retrofitting and new construction of curtain wall facades
Grant Agreement n°	723868
Funding Scheme	Innovation Action
Call	H2020- EEB-2016
Topic	EEB-01-2016 Highly efficient insulation materials with improved properties
Starting Date	1 st August 2016
Duration	49 Months

The present Deliverable D5.1 “Retrofit process application at the individual testing sites” due at M44 (March 2020) of EENSULATE project reports the results achieved within the Work Package 5 “Validation of performance, sustainability and replicability” with particular reference to Task 5.1 “Retrofit process application at the individual testing sites” under FOCCHI responsibility, directed to the design and optimization of EENSULATE retrofitting solutions (EENSULATE VIG, EENSULATE foam and EENSULATE module) for the demo buildings application to be used as testing sites.

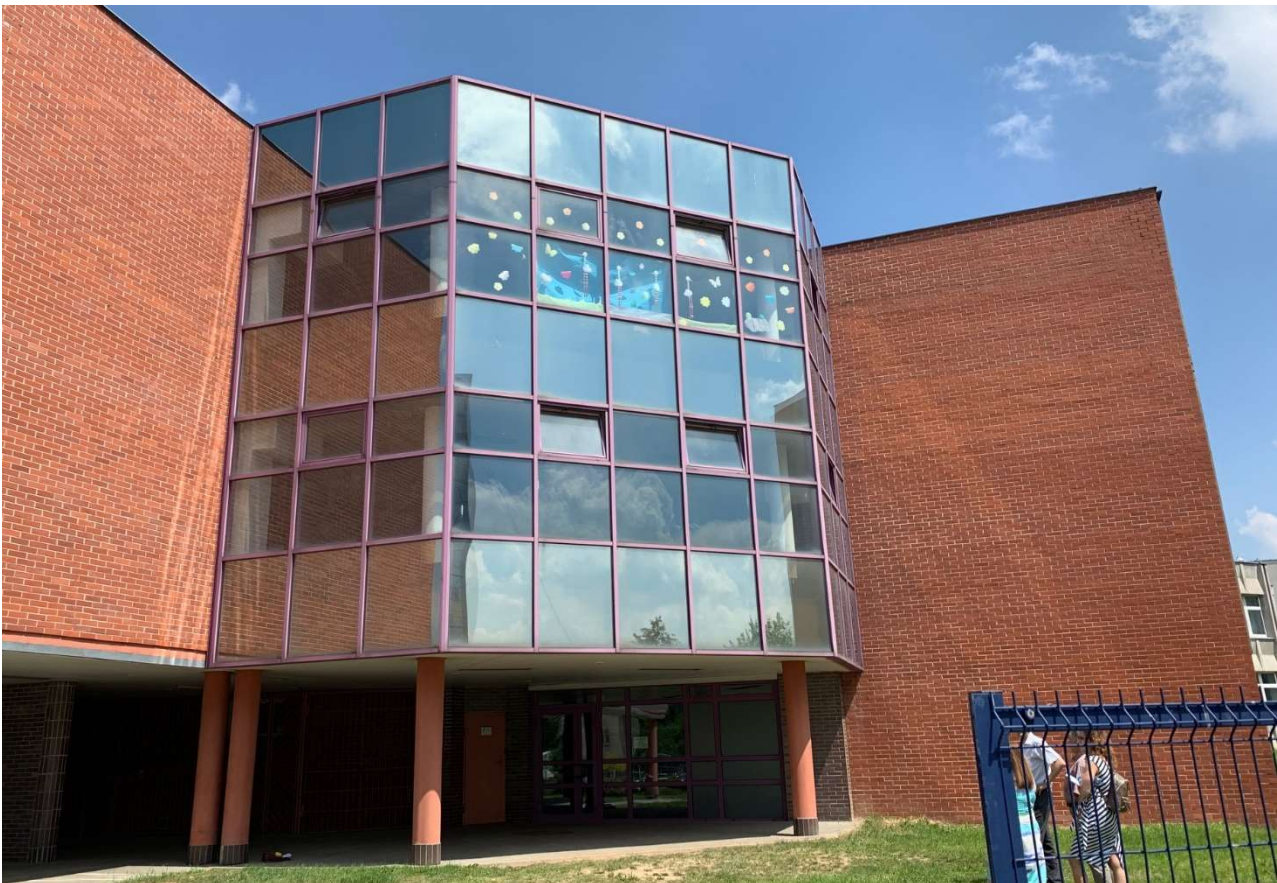
Figure 1: Polish Primary School, Dzierżoniów (Poland). The façade object of retrofitting

The Demo 1 is a Primary School located in Dzierżoniów, Poland owned by Dzierżoniów Municipality (Gmina Miejska Dzierzoniow - GMD) partner of EENSULATE project. The building has been built in 80's and it has a total curtain wall façade surface of around 500 sqm. The EENSULATE project aims at working on a portion of this façade and install the EENSULATE module to increase energy efficiency of the building in line with EU and national targets for public buildings. Object of EENSULATE retrofitting is the façade in Figure 1.

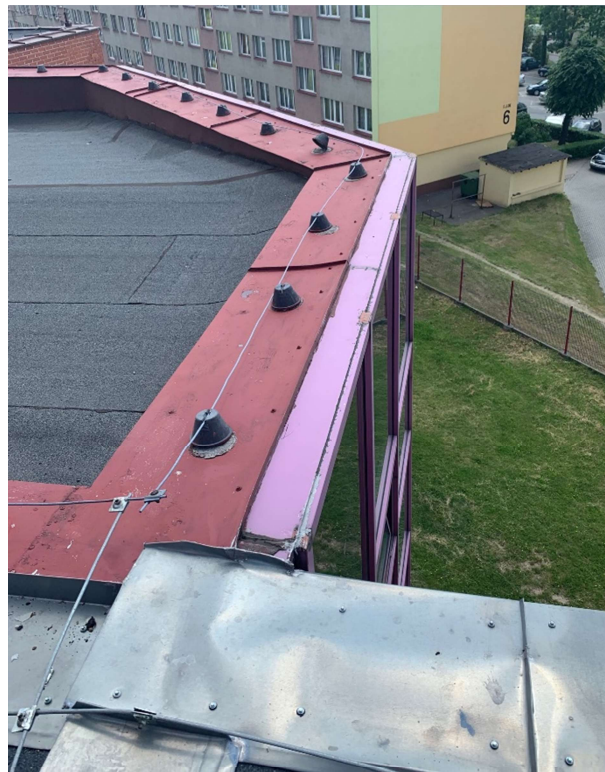
Figure 4: Interface between roof and façade

- **Façade interfaces with existing elements** – the interfaces between EENSULATE module and building elements (walls, ceiling, roof) are other crucial parts to be designed. The concept to manufacture off-site the EENSULATE module is to guarantee a fast to be installed solution on-site. With this purpose as much as possible details need to be designed and solved off-site, reducing at minimum the intervention on-site. The Figure 2, the Figure 3 and the Figure 4 show some pictures of the nodes to be designed.

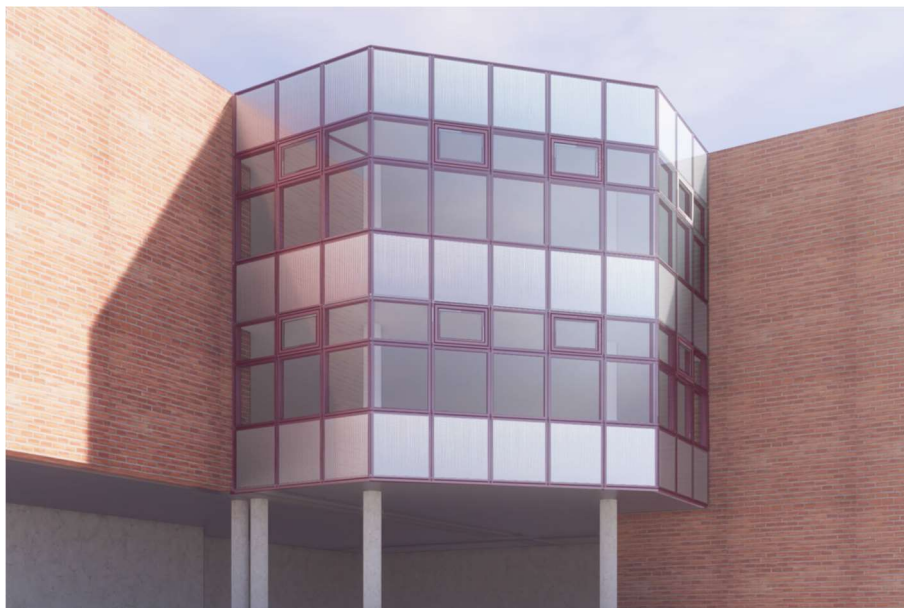
Figure 5: Polish Primary School colour study with RAL 4001. Exterior view

- **Façade colors** – specific request of the municipality is to preserve the aesthetic homogeneity of the retrofitted façade in relation to the other existing façade not object of intervention. For this reason, the application of profile treatment to have similar colors to the ones already present in the building have been conducted.

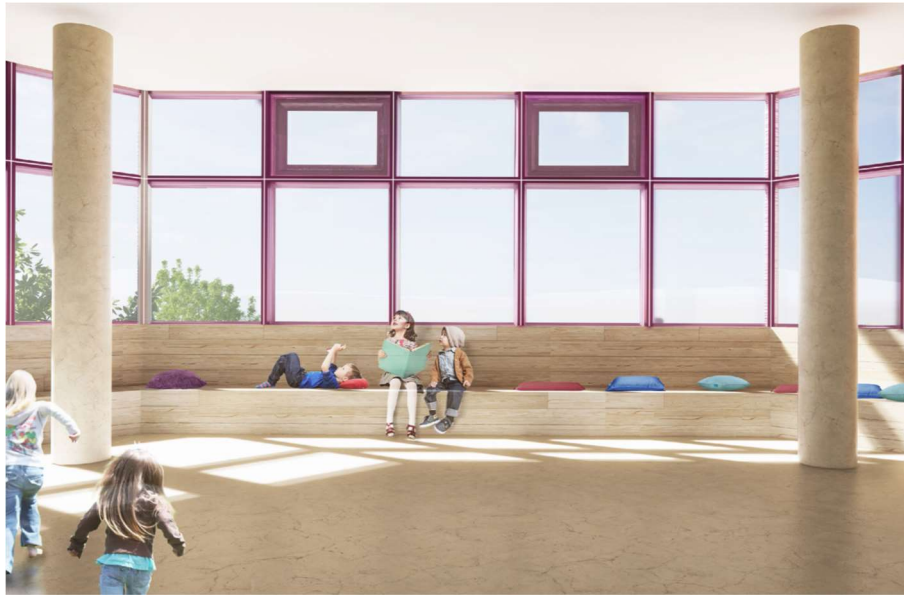
Figure 6: Polish Primary School: colour study with RAL 4001. Interior view

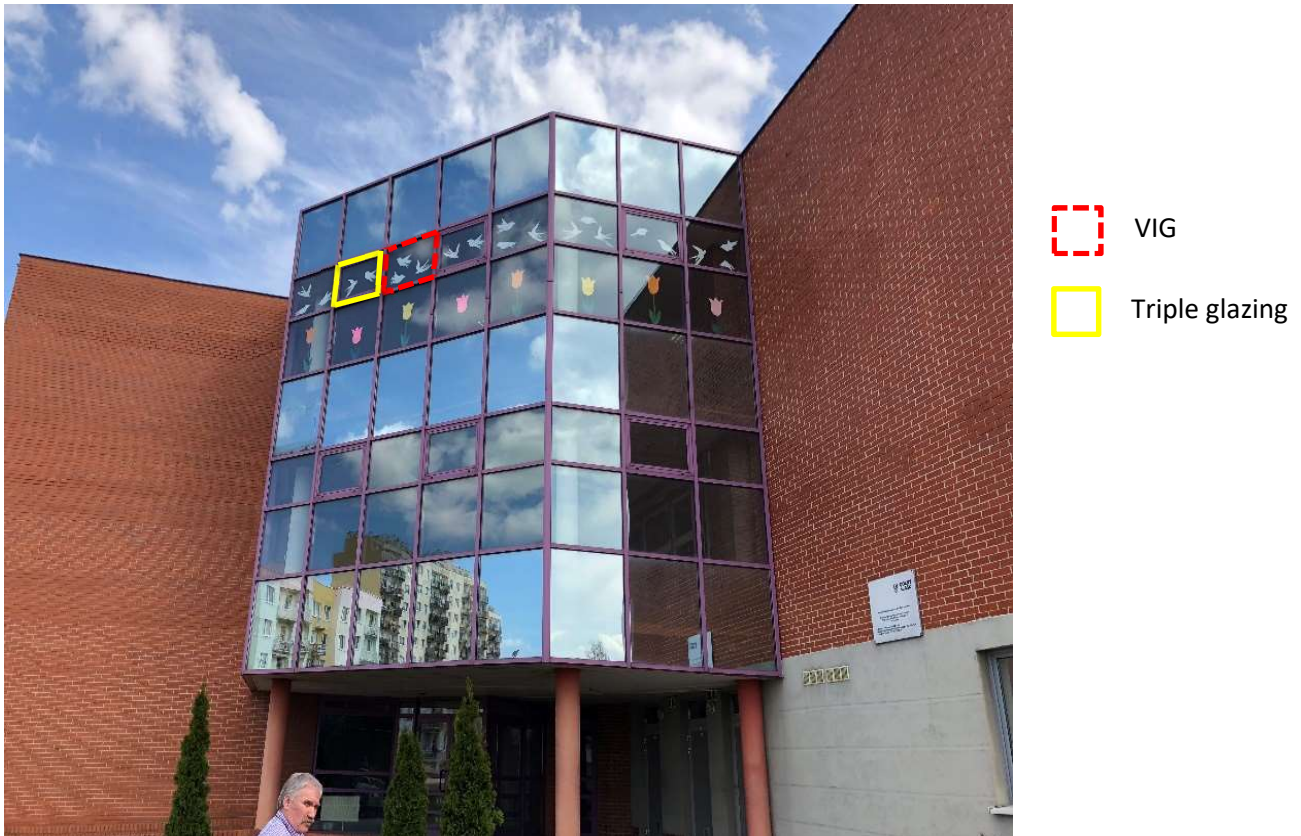
Demo 1 will be exploited to monitor the EENSULATE VIG system performances in a real installation in comparison to a common low energy triple glass (TGU). In order to perform the relative characterization both systems will be monitored with thermal and irradiance sensors. A picture of the Polish Primary School facade is reported in Figure 15, with evidenced in red the EENSULATE VIG system and in yellow the standard glass installed in a frame close to the EENSULATE one.

Figure 15: Polish Primary School facade

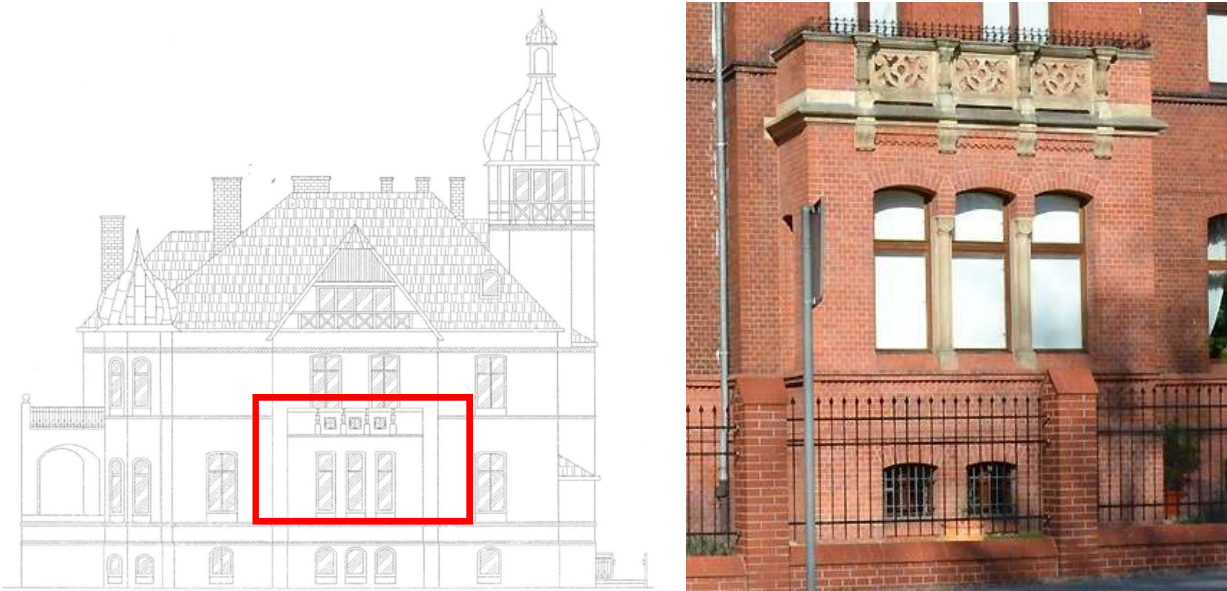
Figure 20: Polish Museum - Side elevation

Existing windows are old box windows with double sash opening to the inside, filled with a single glass. As whole window construction is deteriorated and needs renovation, frame and sash will be repaired by sealing, painting, changing gasket and performing all necessary works required for its proper functioning assessed after evaluation of the particular frames on site.

Old single glass will be replaced with EENSULATE VIG of thickness 12,2mm (6+0.2+6mm) and weight 30kg/m², by dismantling the window sash.

Window sash will be removed carefully in order to perform renovation works, it will be sealed and painted, hardware will be renewed and new gaskets will be attached then single glass will be replaced by VIG. The same sash will be installed in renewed, existing frame. During this intervention, the window opening will be protected against damaging and weather conditions. Thanks to the thorough assessment of necessary works on site the time of intervention will be reduced to minimum.

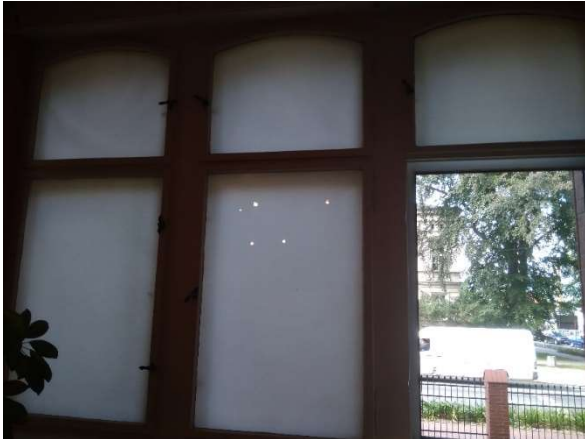
Figure 21: Polish Museum - Internal view of the windows

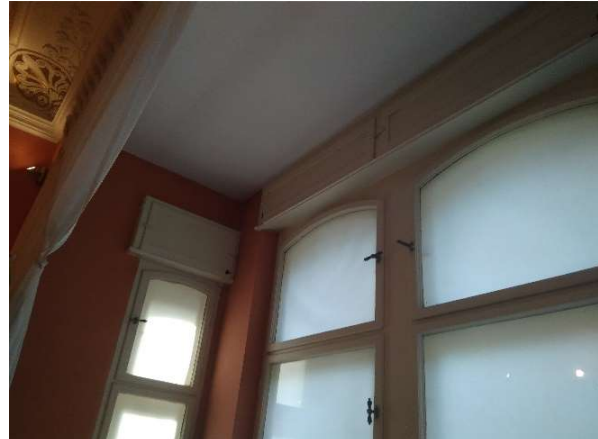
Figure 22: Polish Museum - Window view with old roller shutter boxes.

Additional as originally windows were equipped with old roller shutters no longer used, existing coffers will be filled with insulating foam developed by project partner, in order to minimize thermal bridges.

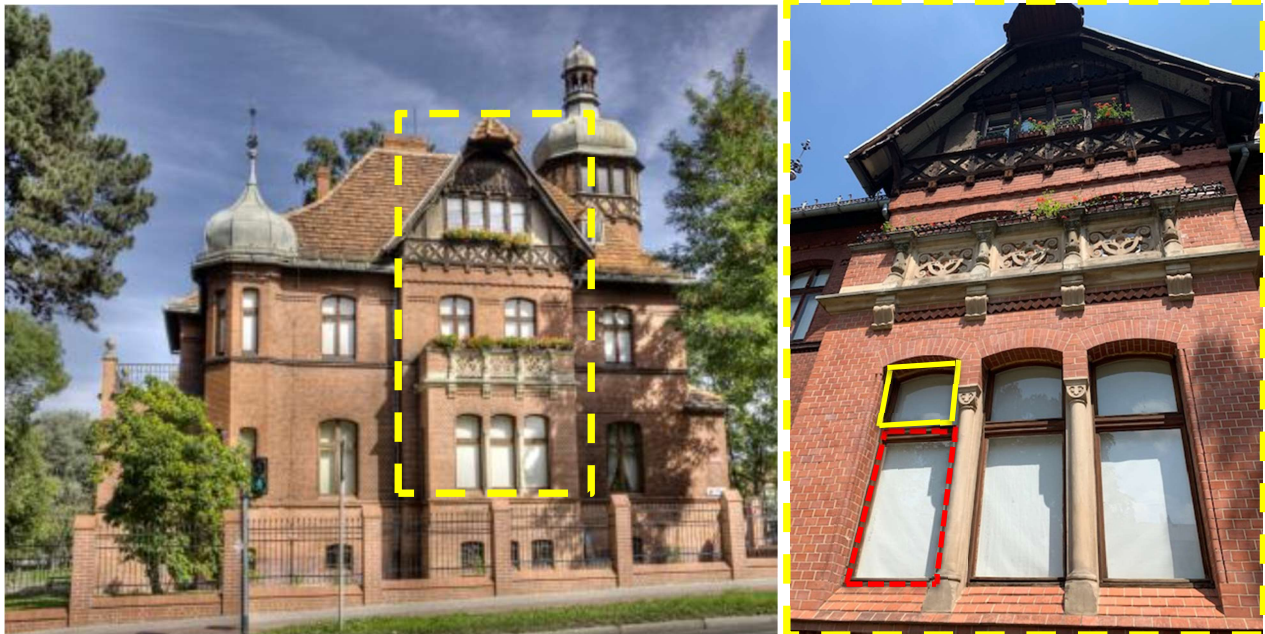
Also Demo 2 – Polish Museum will be monitored to estimate relative glass transmittance performances, therefore two glass systems will be monitored: the one that includes the EENSULATE system (dashed red line in Figure 23) and the traditional one (solid yellow line in the same figure). In addition, in the Dzierżonowie Museum, the thermal comfort will be monitored. To this aim the following quantities will be measured:

Figure 23: Polish Museum front and zoom on the window to be monitored

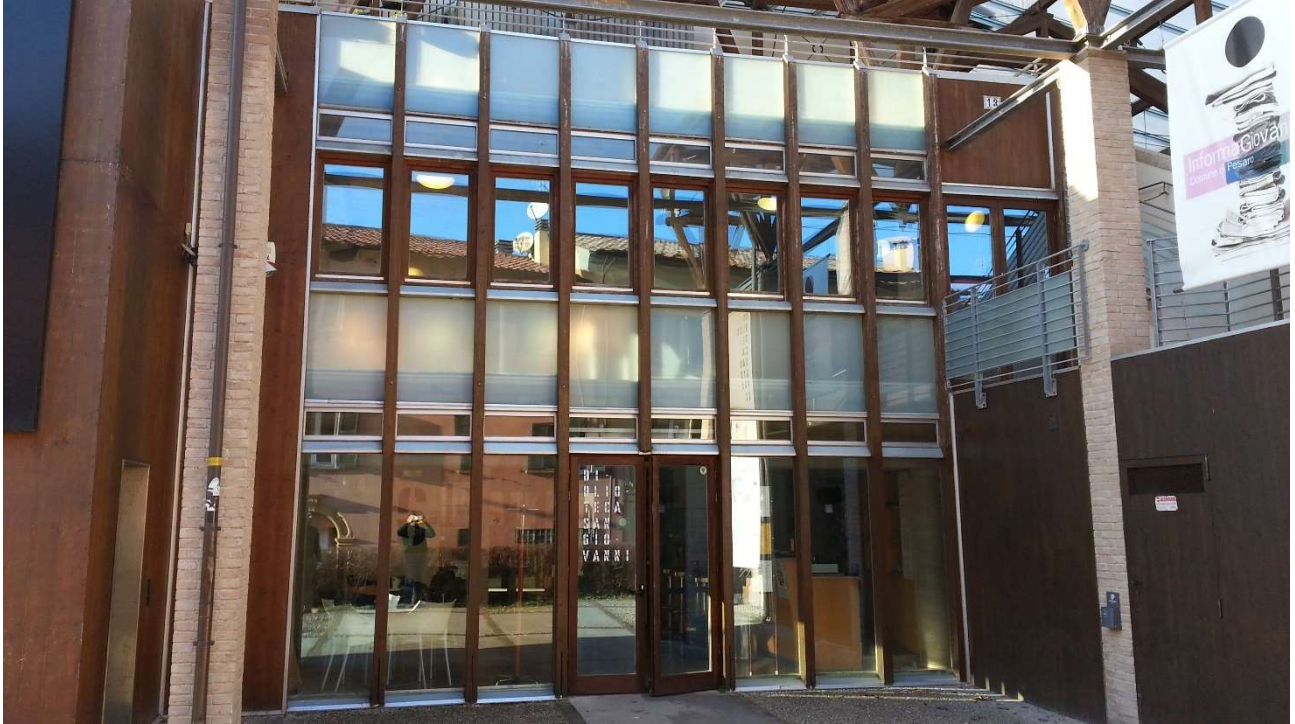
- **Façade in the rear entrance** – curtain wall façade with wooden frame and Double Glazed Unit (DGU). The retrofitting of this façade would have maintained the existing wooden frame, but the existing DGU would have replaced with VIG; in the correspondence of spandrel part, the EENSULATE foam

Figure 28 San Giovanni Public Library: Façade in the rear entrance.

could have been tested. However, the intervention on this façade was excluded due to the huge amount of VIGs to be manufactured.

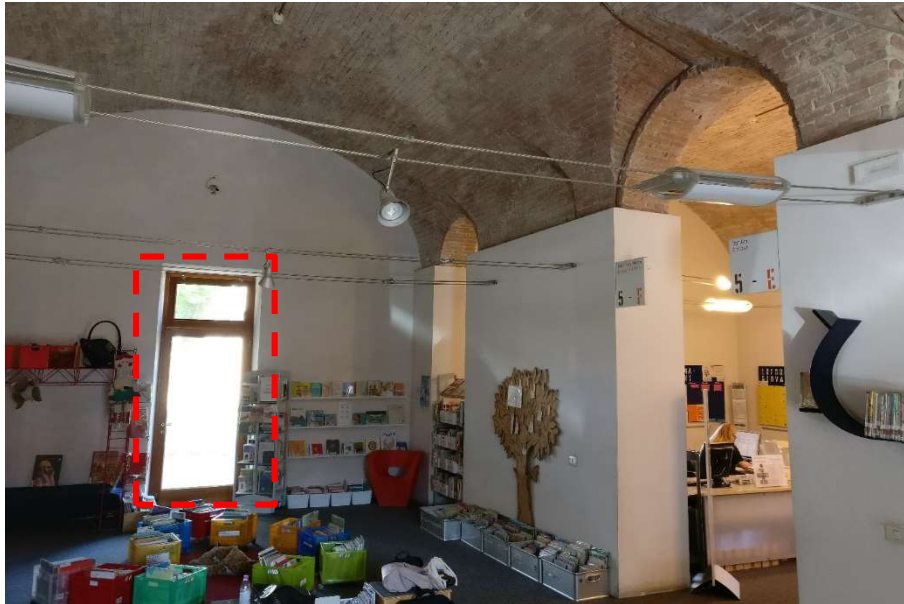
- **Door-window** – along the main corridor of the Library, there is a long interior with door-windows with wooden frame and DGU. In this case the retrofitting will include the EENSULATE VIG utilization replacing the existing DGU. Not affecting the aesthetic of the building, this EENSULATE VIG application is the one object of retrofitting in this demo.

Figure 32 - San Giovanni Public Library: door-window

The retrofitting of the door-window plans to preserve the overall window frame and replace only the DGU (28 mm) with the VIG (18 mm). The intervention will be conducted removing the internal aluminium frame which restrains the DGU, cleaning the area from the existing sealant, placing the VIG, sealing the edge to create air and water tightness performance and repositioning the aluminium restrain in their initial position.

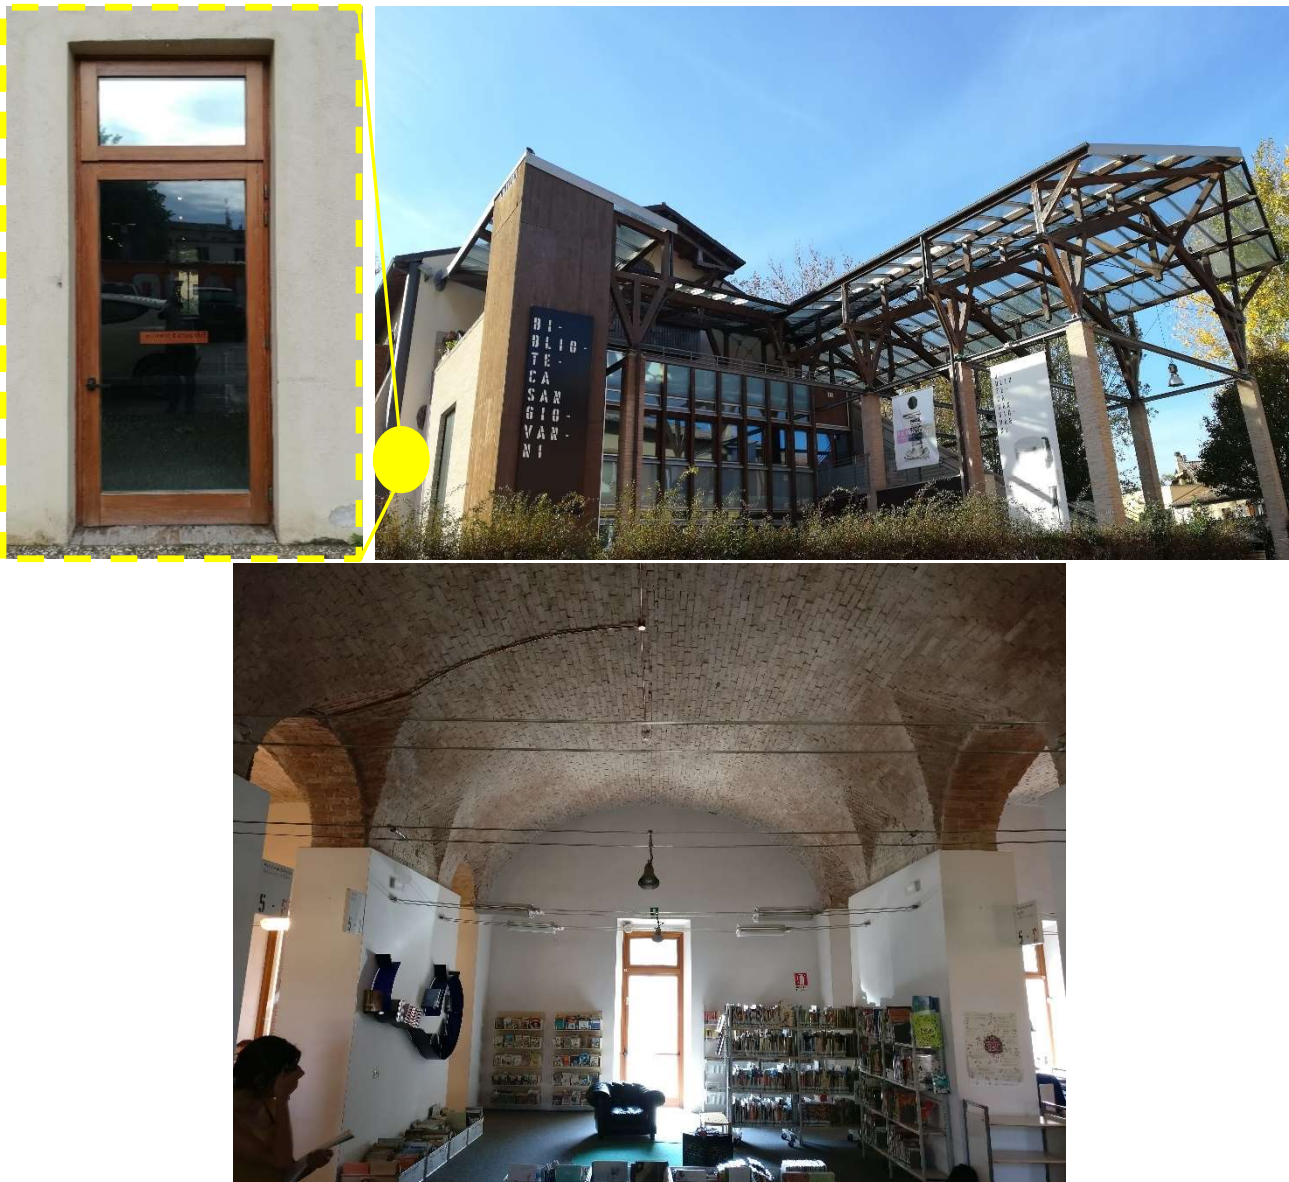
Demo 3 (San Giovanni Public Library) will be monitored in terms of glass transmittance and room comfort as for Demo 2 (Polish Museum). In addition, in this historical building, the wall transmittance is measured as well by means of a heat flux meter and thermocouples installed on the internal and external surface of the wall itself. The same quantities as for Demo 2 will be measured with the same sensors with an exception: the comfort will be monitored by a unique system which is the Comfort Eye patented by UNIVPM.

Figure 35: San Giovanni library and window chosen for monitoring

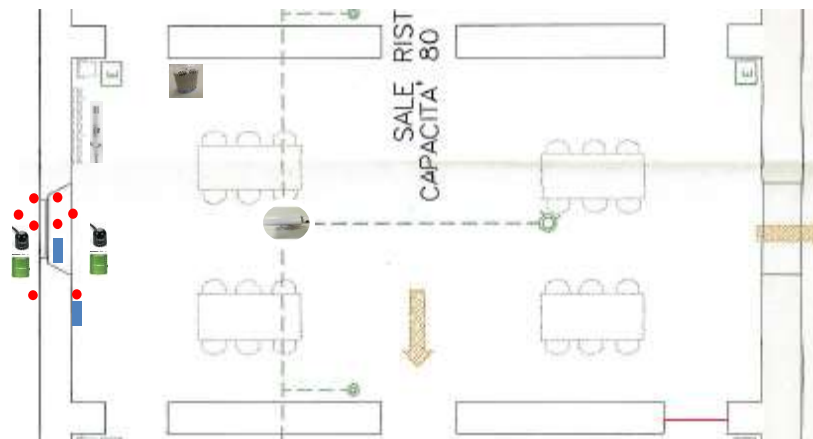
- Thermocouples
- Heat flux meter
-   Pyranometer
- Luxmeter
-   Comfort Eye
-   Thermo hygrometer

Figure 36: Set-up of the glass transmittance monitoring sensors and comfort instrumentation – Demo 3

The acquisition system is a Keysight 34972A hosting a 20 Channel Multiplexer (Keysight 34901A module) for voltage and current acquisition. Like for Demo 1 and 2, the control system includes a mini PC and a router for communication with external and remote devices.

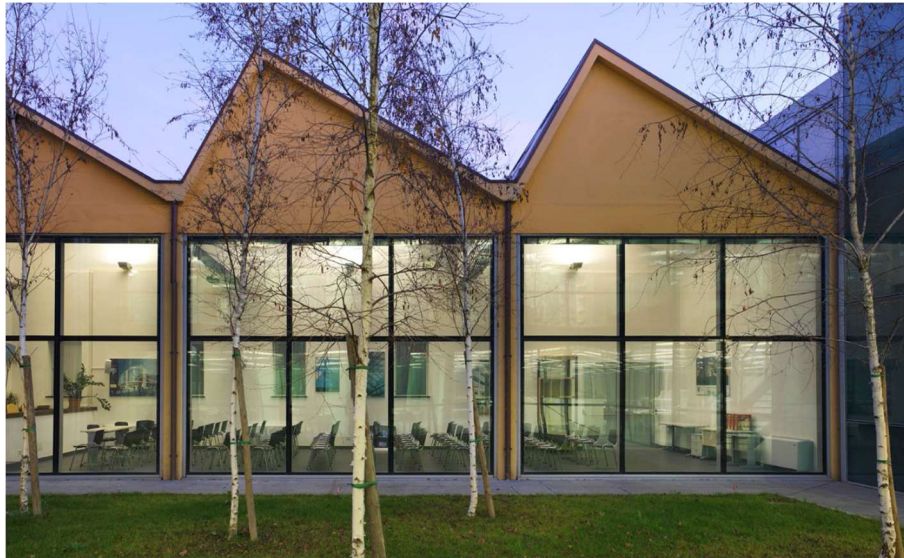
- **Conference room** – the conference room has full glass surface with DGU for a total of 95 sqm. The retrofitting will have included the replacement of the DGU with the VIG. This façade has been discarded due to the amount of VIG to be manufactured and within the contingency plan to achieve the EENSULATE project expected outputs.

Figure 40: Focchi Headquarter's conference Room

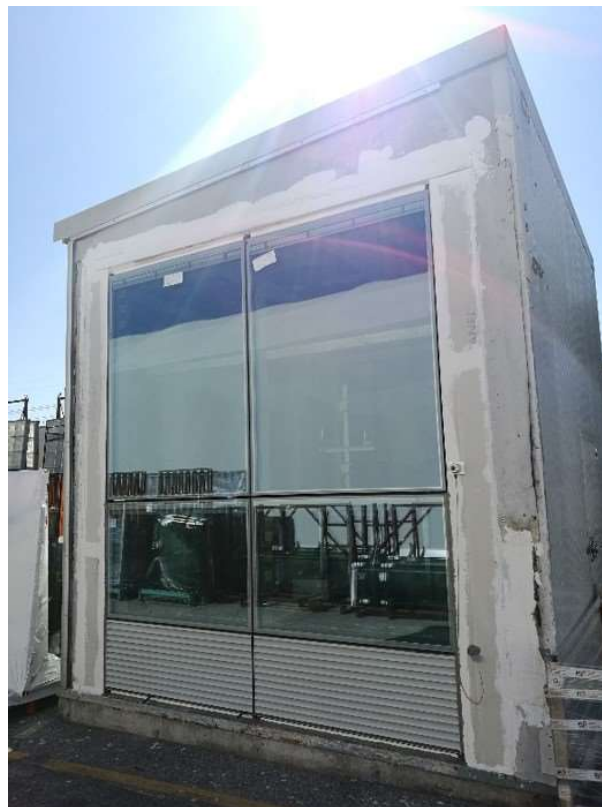
- **Testing Lab** – the Testing Lab could change the existing façade with other façade solution. In this case, the EENSULATE module would have been installed and its performances testes. This solution has been discarded because did not compel with the need to have a “living environment” to test the EENSULATE solutions.

Figure 41: Focchi Headquarter's Testing Lab

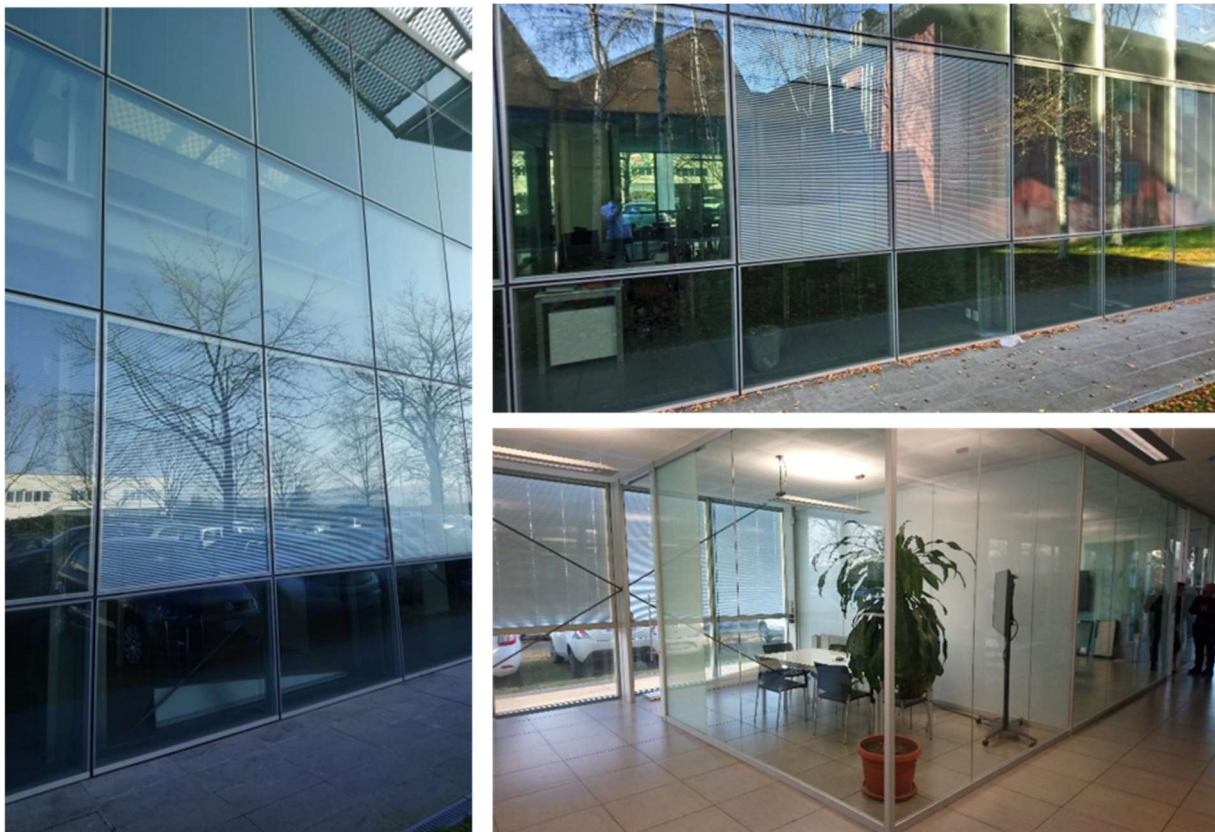
- **Factory's windows** – one of the facilities in Focchi Headquarters has some windows with TGU installed. In this case, the retrofitting strategy would have replaced the existing glass with EENSULATE VIG. The solution was not considered relevant for the project purpose and to validate large scale VIG.
- **Meeting Room** – inside the office building, the meeting room has the possibility to replace the TGU with VIG testing a retrofitting with EENSULATE VIG in a full scale (1,5 m x 2,0 m), but in a small space

and having a living environment to support the validation. This solution has been considered the one to be selected among Focchi alternatives and it has been object of retrofitting design.

Figure 43: Focchi Headquarter's meeting room in Focchi Office

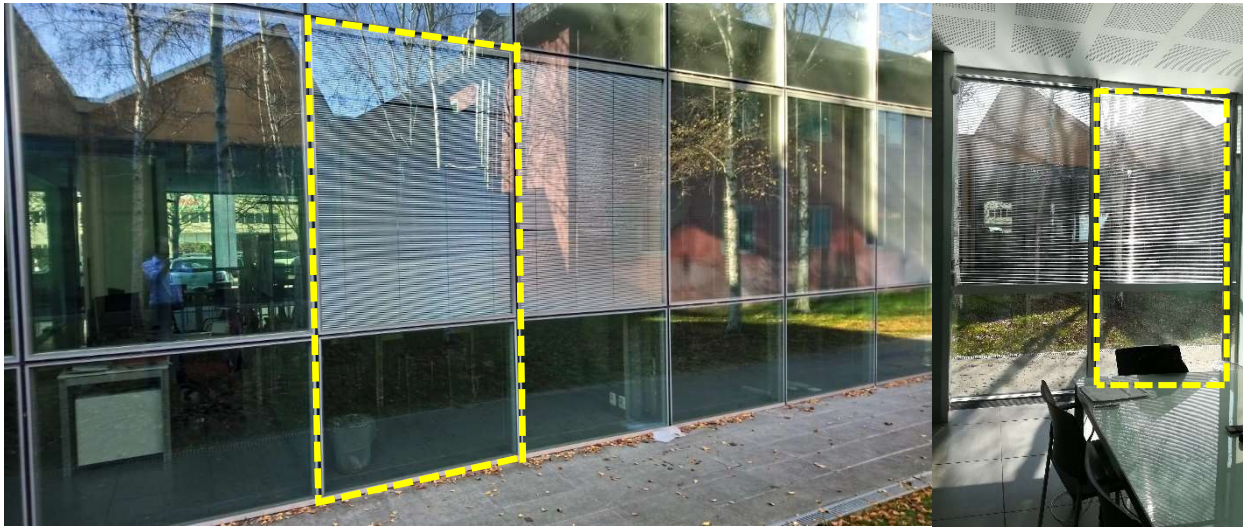
Figure 50: Focchi Headquarters meeting room monitored

Demo 4 can be monitored in terms of glass transmittance and indoor comfort as Demo 2; the glass chosen for the monitoring is marked in yellow in Figure 50. As for Demo 3, the sensors were installed in Demo 4 and data are available since May 2019.

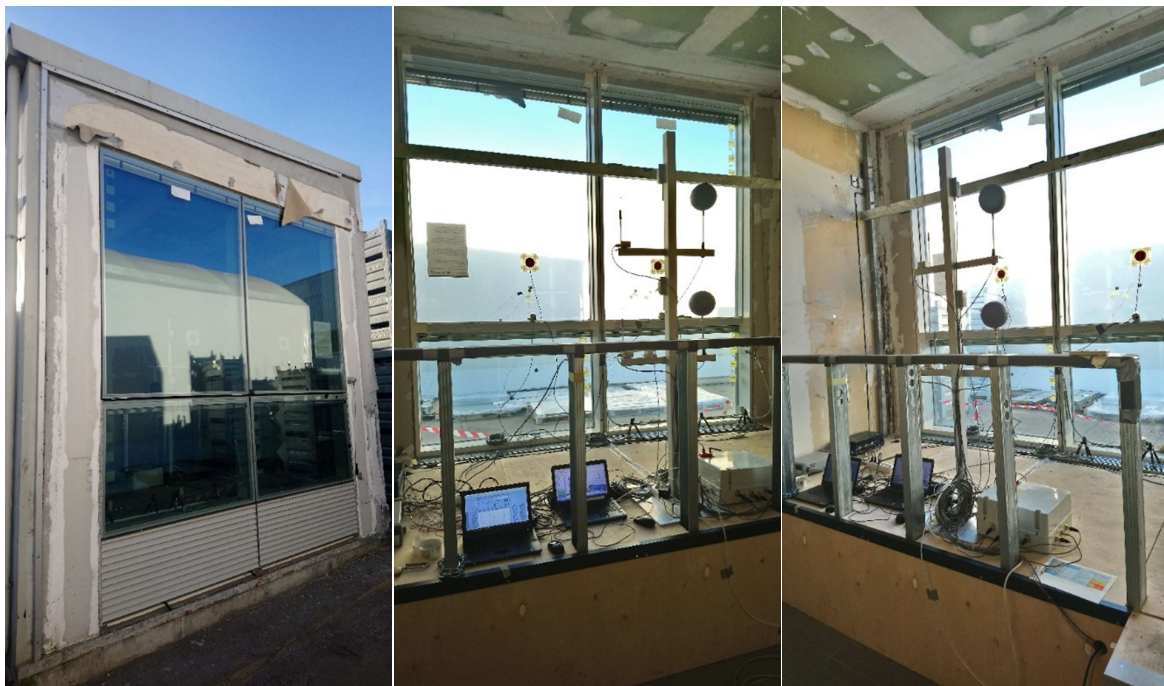
Figure 53: Focchi mock-up demo

Table 5. Two glazed systems and a wall of the mock-up were instrumented with thermocouples and heat flux meters to measure the thermal transmittance. The radiation energy entering the room was measured via four pyranometers, one placed outdoor close to the first glazed system and two placed indoor close to both the glazed systems and one placed in the middle of the room. The visible radiance was measured by a luxmeter located in the center of the room. The indoor comfort was assessed by calculating the quantitative indicator called PMV (Predicted Mean Vote) derived from the measurement of mean radiant temperature, relative humidity and air velocity at two nodes in the room. The monitoring of two zones inside the room had the objective of verifying if comfort inhomogeneity occurred. The room was therefore ideally divided into a lower and an upper zone. The mean radiant temperature, relative humidity and air velocity in the two zones were measured by two globe-thermometers, two thermo hygrometers and two anemometers. To monitor energy consumption, the power absorbed by the HVAC system installed in the mock-up was measured. The sensors, acquisition and control components list and installation scheme are detailed in Table 5 and Figure 54.
